North Coast Regional Water Quality Control Board

Subject: **Inspection Report for August 21, 2018, Warrant Inspection of Humboldt County APN: 214-142-008-000, 214-142-009-000 and 214-142-011-000**

File: Cannabis Program Inspections, Humboldt County, August 2018 HCSO Inspection, WDID 1B161040CHUM

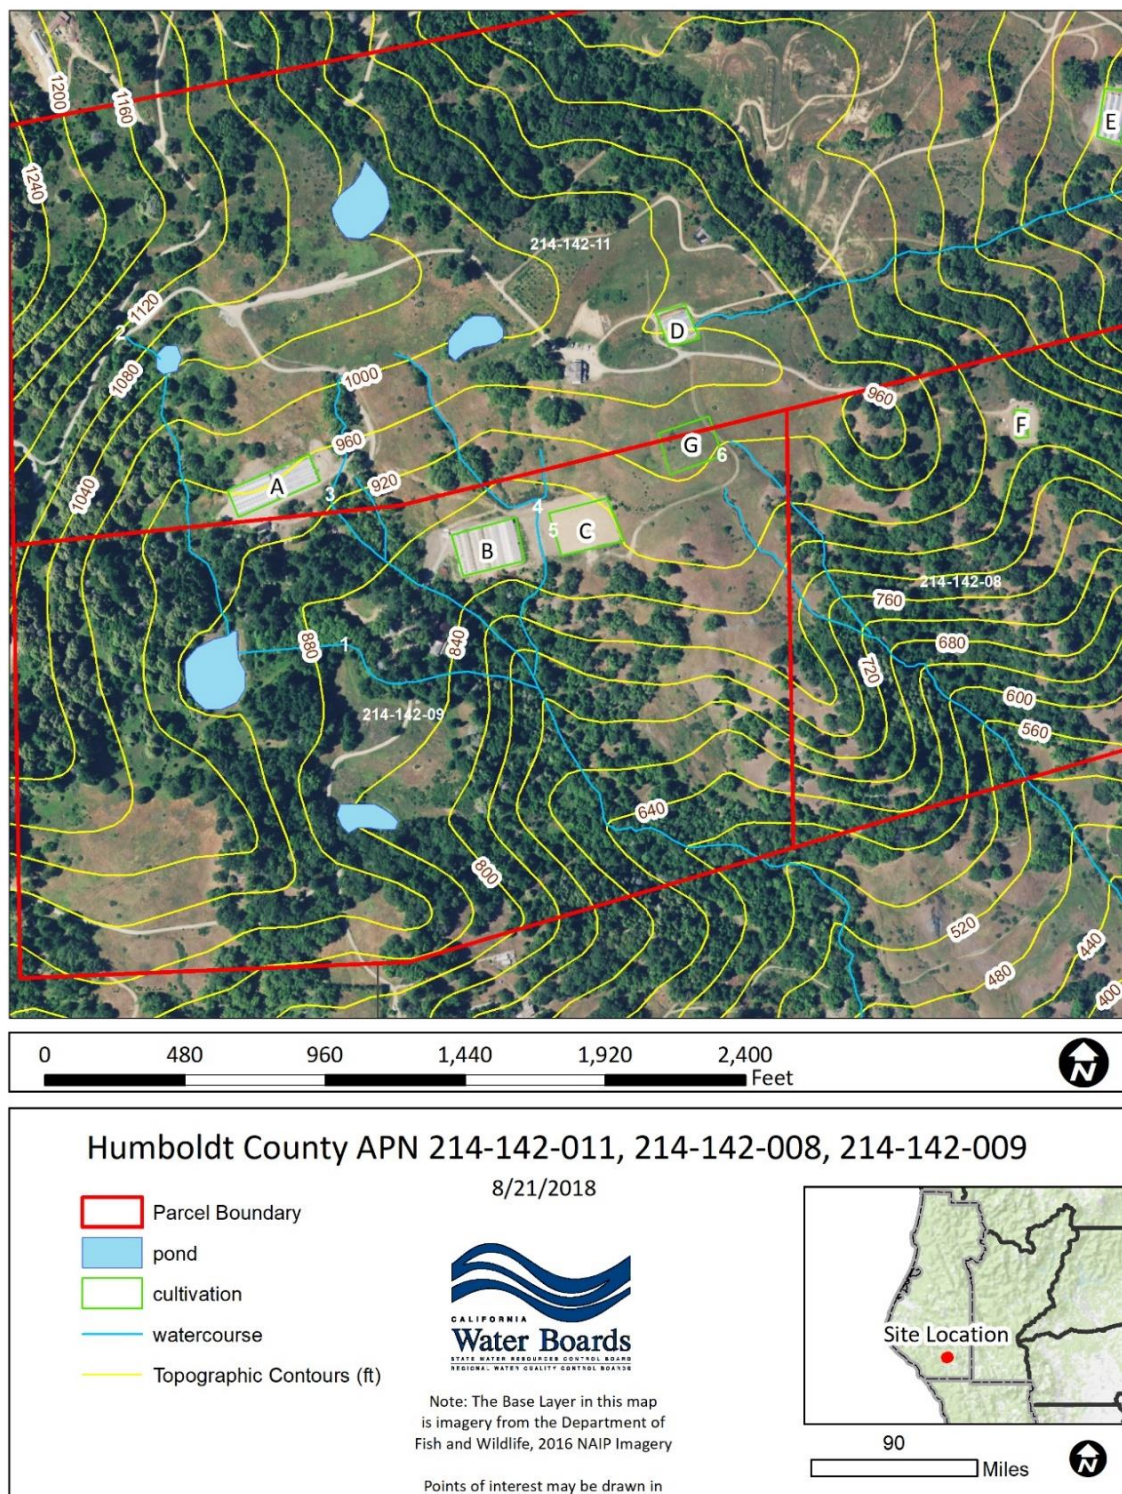
Inspection Map

The Inspection Map, above, shows the inspection features identified and discussed below.

<i>Map Point</i>	<i>Feature</i>	<i>Brief Description</i>	<i>Water Quality Concern</i>	<i>Associated Photo(s)</i>
1	Water diversion	Water diversion infrastructure left in channel.	Waste in a watercourse.	1
2	Old culvert	Rusted undersized culvert discharges spring flow	Rusted culvert may fail, resulting in water eroding the road surface, transporting pollutants towards surface water. Threatened discharge of waste to surface water.	2, 3
3	Culverted watercourse	Cultivation pad constructed over a watercourse. Watercourse is culverted over 160' length.	Dredge/fill in a surface water.	4 - 6
4	Graded wetland	Graded and filled wetland.	Dredge/fill in a surface water.	7 - 12
5	Potting Soils	Bag of potting soil stored uncovered on bare ground within 50 feet of watercourse.	Threatened discharge of waste to receiving waters.	13
6	Road Maintenance	Steep, unrocked road is susceptible to erosion from stormwater.	Threatened discharge of waste to receiving waters.	14
